Manhole Inspection Summary

Manhole # S11C1_008MH

Insp Date: **1/8/09 11:23 AM**

Location Address: **1401 Bloomfield Ave.**

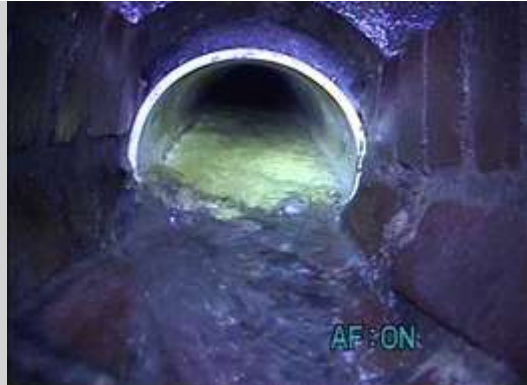
12 O'Clock Outflow

Pipe Height: **8.4** (in.) Rod and Bar (Angled)
Pipe Material: **PVC** ☐ Pipe Lined
Invert Depth: **13.02** (ft.) Flow Characteristics: **Fast**
Deposits: ☒ None ☐ Mud ☐ Sludge ☐ Debris ☐ Grease
Silt Depth: **0** (in.) Deposits Extent:
Infiltration: **None** Pipe Seal Cond: **Sound**

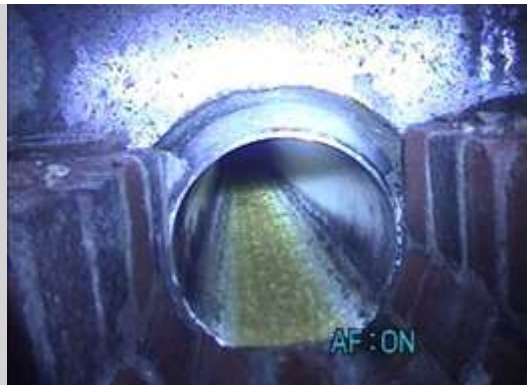
5 O'Clock Inflow

Pipe Height: **8.4** (in.) Rod and Bar (Angled)
Pipe Material: **PVC** ☐ Pipe Lined
Invert Depth: **12.78** (ft.) Flow Characteristics: **Fast**
Deposits: ☒ None ☐ Mud ☐ Sludge ☐ Debris ☐ Grease
Silt Depth: **0** (in.) Deposits Extent:
Infiltration: **None** Pipe Seal Cond: **Sound**
